AgustaWestland Products

SERVICE BULLETIN

_№ 189-237

ATA 64 - TAIL ROTOR FLIGHT CONTROL IMPROVED PERIODICAL INSPECTION

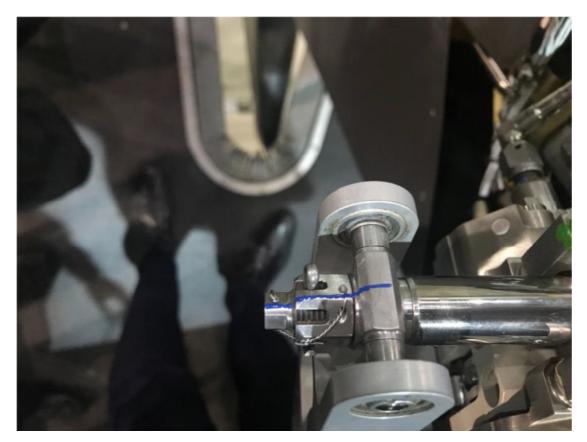
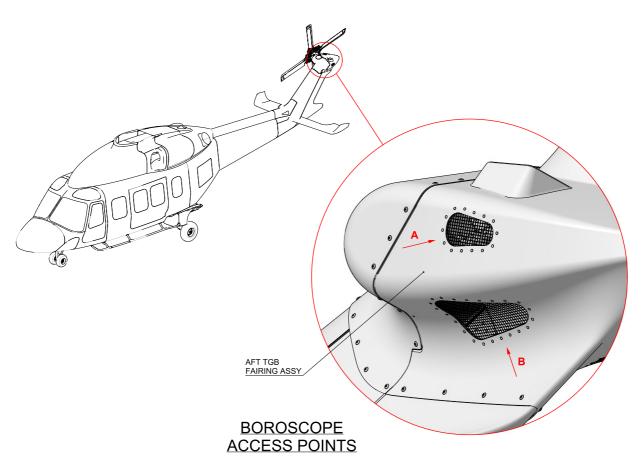
Figure 3

- 4. With reference to Figure 3, check the slippage mark on the castellated nut for absence of evidence of rotation between the parts. Record the result on Table I (refer to Figure 7).

- 5. If any evidence of rotation is found, contact the Product Support Engineering (pse aw189.mbx.aw@leonardocompany.com), wait for further instructions before to perform the following checks:

- 10.9 With reference to Figure 3, restore the slippage marking on the castellated nut from the hinge bracket element to the rod.
- 11. In case replacement of the TR duplex bearing is required, please return immediately (within 2 days) the removed TR duplex bearing and the collecting containers of the grease to Leonardo Helicopters. Contact the Product Support Engineering (pse aw189.mbx.aw@leonardocompany.com) to receive the proper instructions to return the removed component.

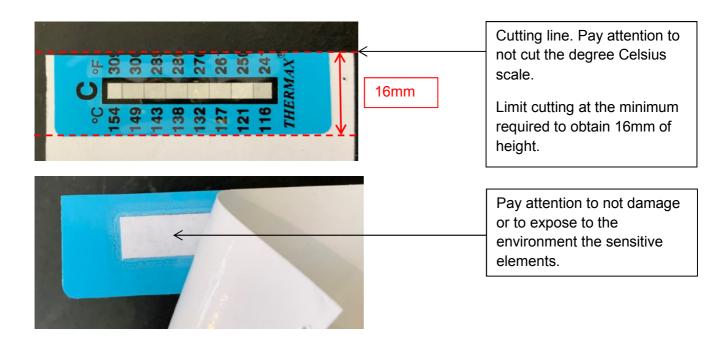
Do not use a thermal strip if after having trimmed it, its sensitive element is exposed to air. See below an example of a badly cut strip.

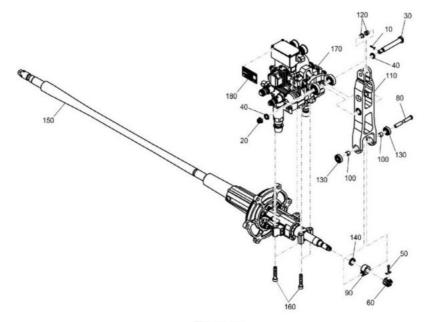
Figure 1a

To check and re-apply the torque of the castellated nut (60) connecting the rod (150) to the input lever (110) of the Tail Rotor Actuator (see Fig. 1a and 1b).
